**TRAFFIC SIGN STUDY**

**CHIEF IBRAHIM Y. HAROON**

## Speed Study Mink Street near Hillview Drive

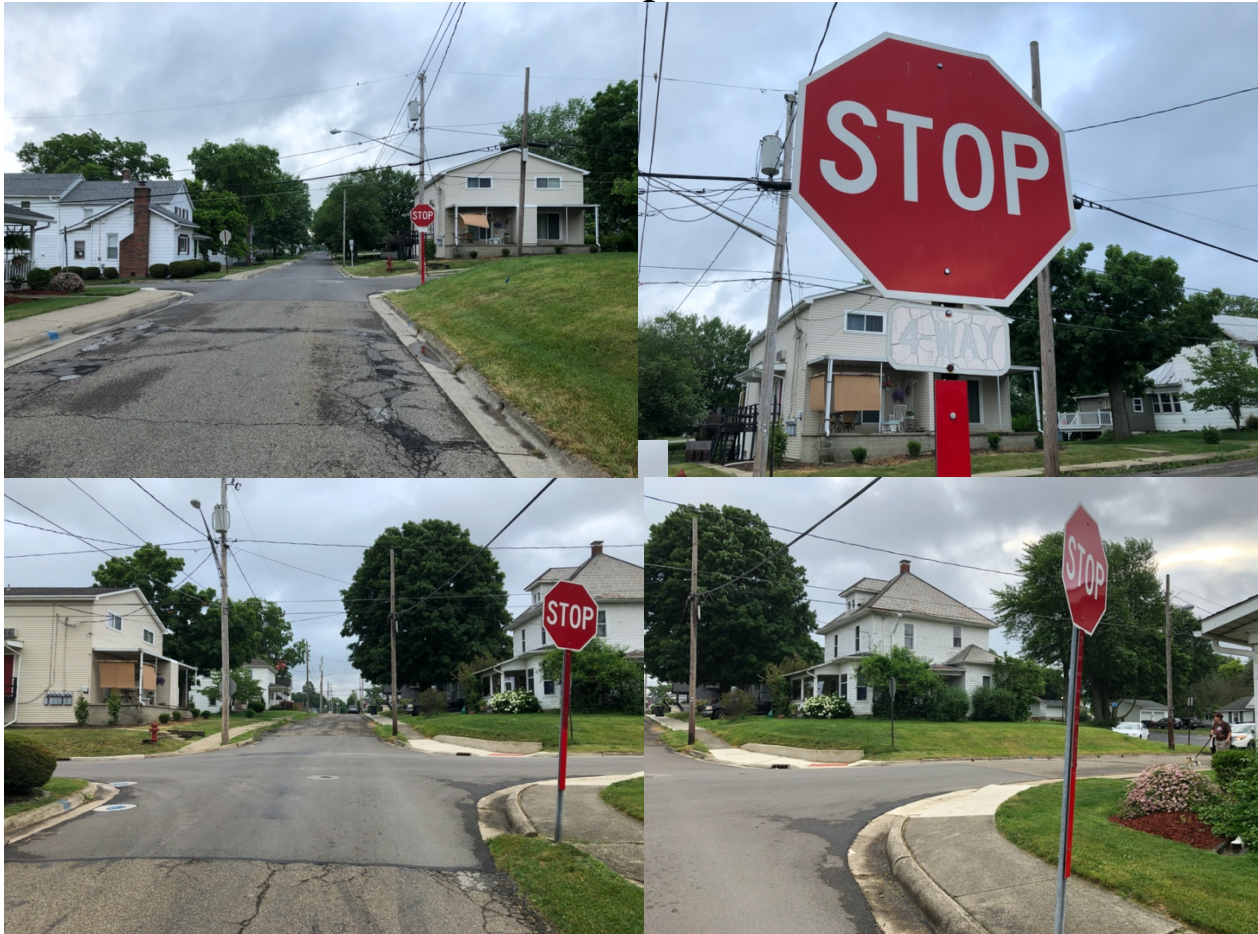
### **South Oregon Street at West Collage Street**

**Onsite observations:** Relatively open roadway with overhead wiring. The wiring is likely to be that of communications and power. This intersection does transition from relatively poor asphalt that may hinder the friction of rubber tires, to moderately worn asphalt that would likely be close to ideal for surface gription. Most traffic control devices (stop signs) within this intersection are in conformance with the Ohio Revised Code. They are placed at an appropriate height, reflective, placed inconspicuously, and perpendicular to the lane of travel. With the aforementioned stated, none of the signs adequately state; “4-WAY.” As the under signage is faded or missing. The sign on the southwest corner is tilted and likely not to be viewed as perpendicular. It was also noted that none of the stop signs had an accompanying stop-bar (white line). While this is not a conformance matrix (if no stop-bar is present, the vehicle will stop in relation to the posted sign), it is my recommendation that they be added for improved visibility.

The area is likely to be problematic and stop sign violations are likely occurring. I will consider this a target enforcement area. While successful defense strategies are likely not to be upheld, I do recommend that the faded and missing “4-WAY” signs be replaced or added, and the tilting signs be re-erected. Last, some consideration should be made to add or repaint the stop-bars at the foot of all stop signs within the venue. Please enquire if you have further questions.

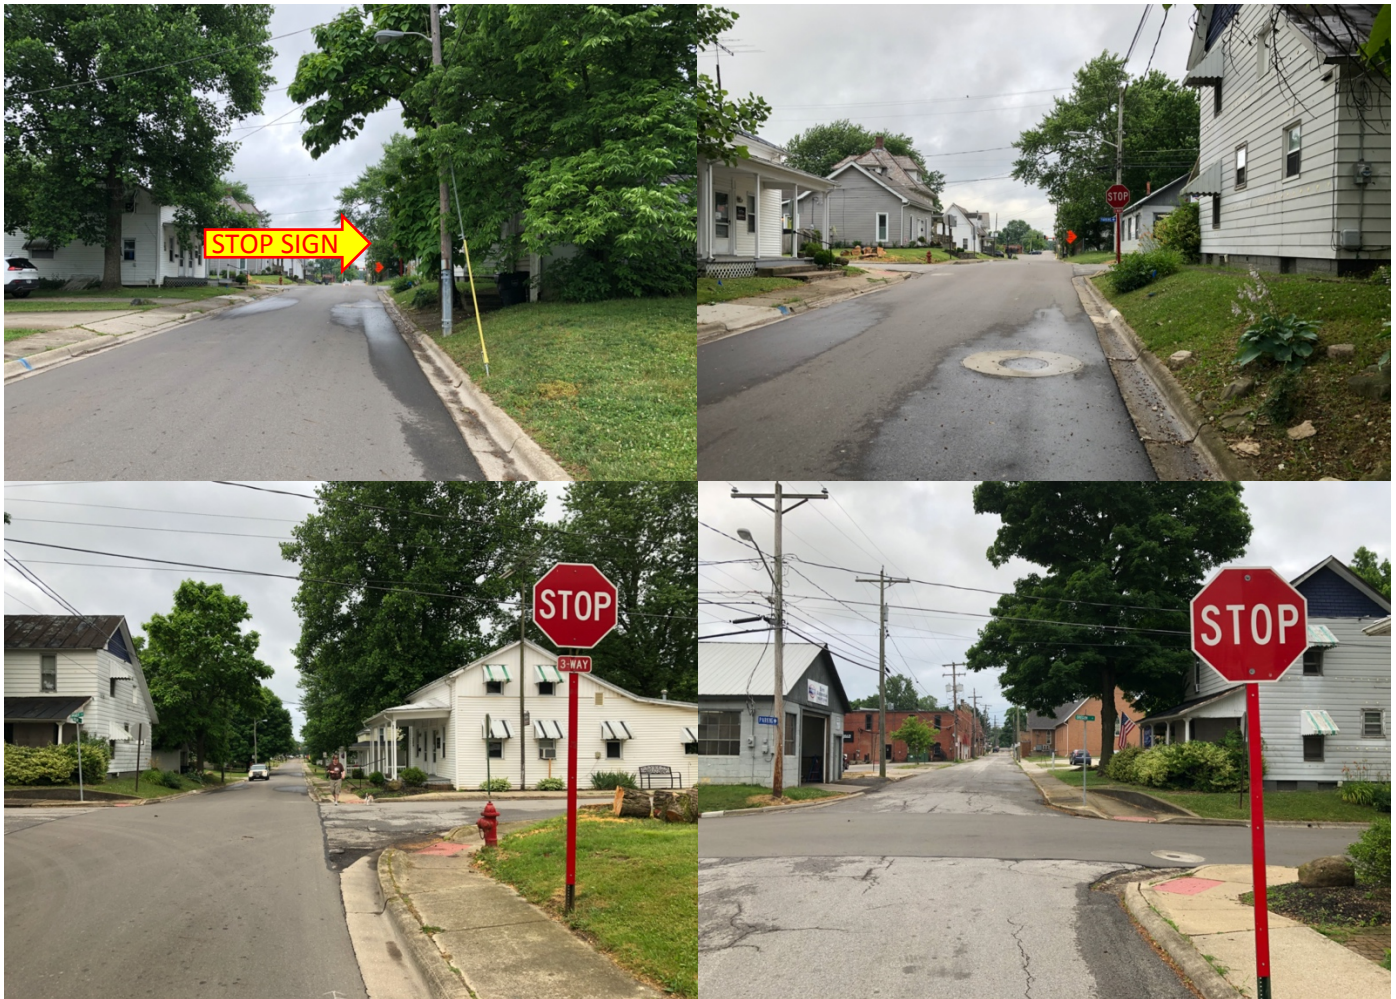
### **South Oregon Street at West Pratt Street**

**Onsite observations:** Relatively open roadway with overhead wiring, some low hanging tree branches are obstructing the view of the traffic control device (stop sign). The wiring is likely to be that of communications and power. This intersection is moderately worn asphalt that would likely be close to ideal for surface gription. Most traffic control devices (stop signs) within this intersection are in conformance with the Ohio Revised Code. They are placed at an appropriate height, reflective, placed inconspicuously, and perpendicular to the lane of travel. With the aforementioned stated, only some of the signs adequately state; "4-WAY." As some of the under signage is missing. It was also noted that none of the stop signs had an accompanying stop-bar (white line). While this is not a conformance matrix (if no stop-bar is present, the vehicle will stop in relation to the posted sign), it is my recommendation that they be added for improved visibility.

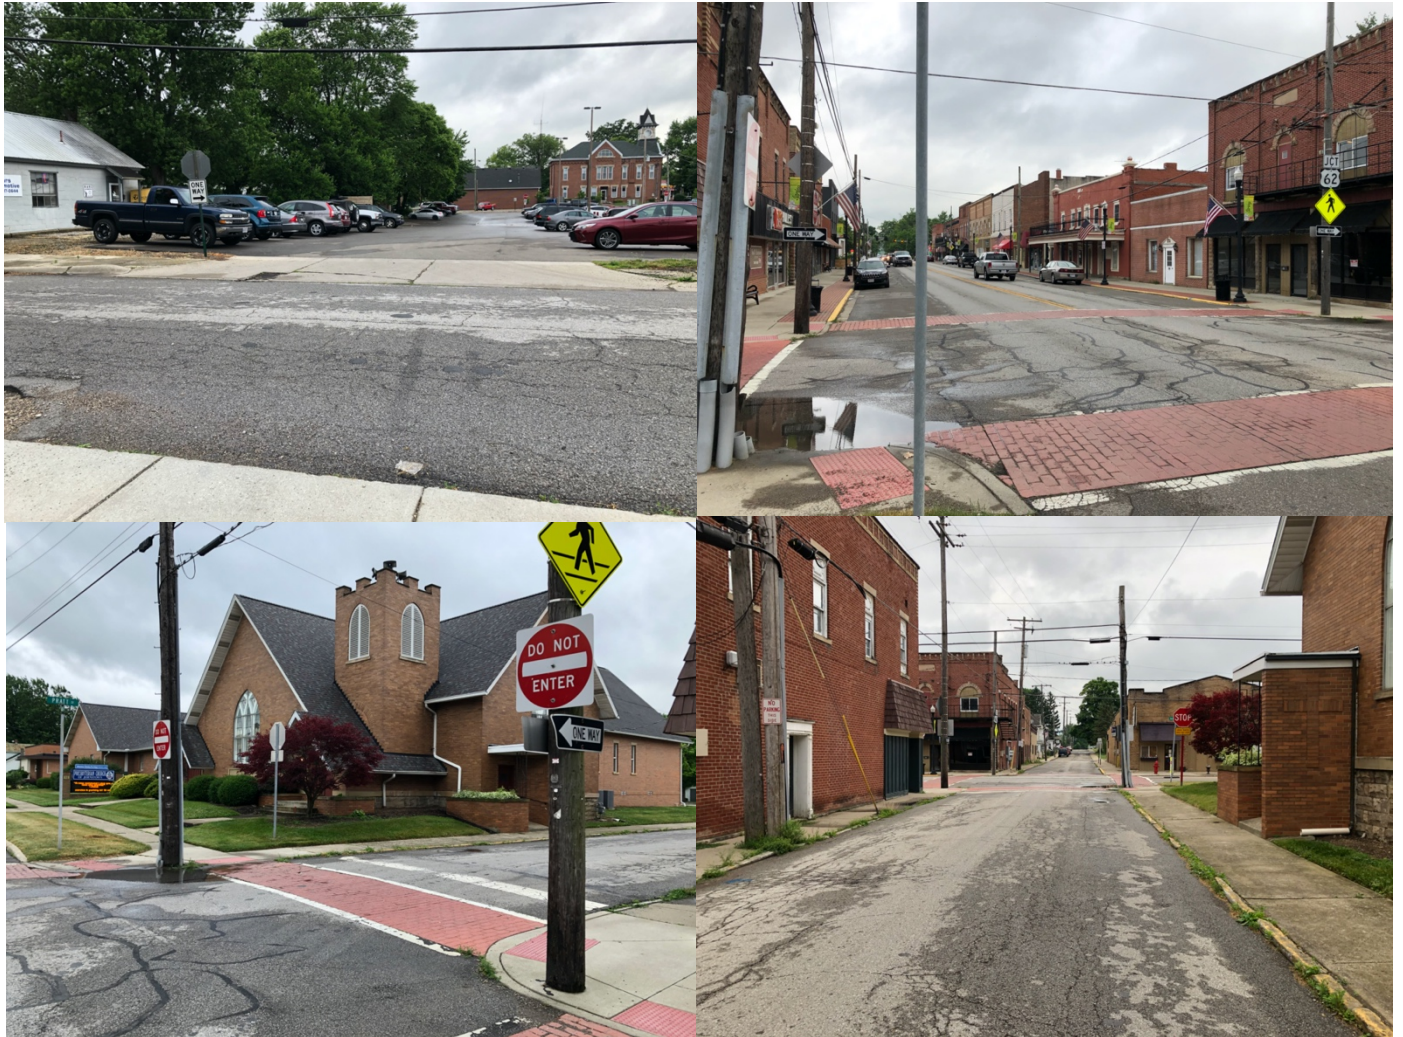
### West Pratt Street (One-way)

**Onsite observations:** Relatively open roadway with overhead wiring. The wiring is likely to be that of communications and power. This roadway is relatively poor asphalt that may hinder the friction of rubber tires. All traffic control devices (DO NOT ENTER & ONE WAY) are in conformance with the Ohio Revised Code. They are placed at an appropriate height, reflective, placed inconspicuously, and perpendicular to the lane of travel. It was noted that the stop sign at the intersection of West Pratt Street and South Main Street was slightly obscured by a small tree. It was also noted that the stop signs had an accompanying stop-bar (white line). I had no outward recommendations for this area.

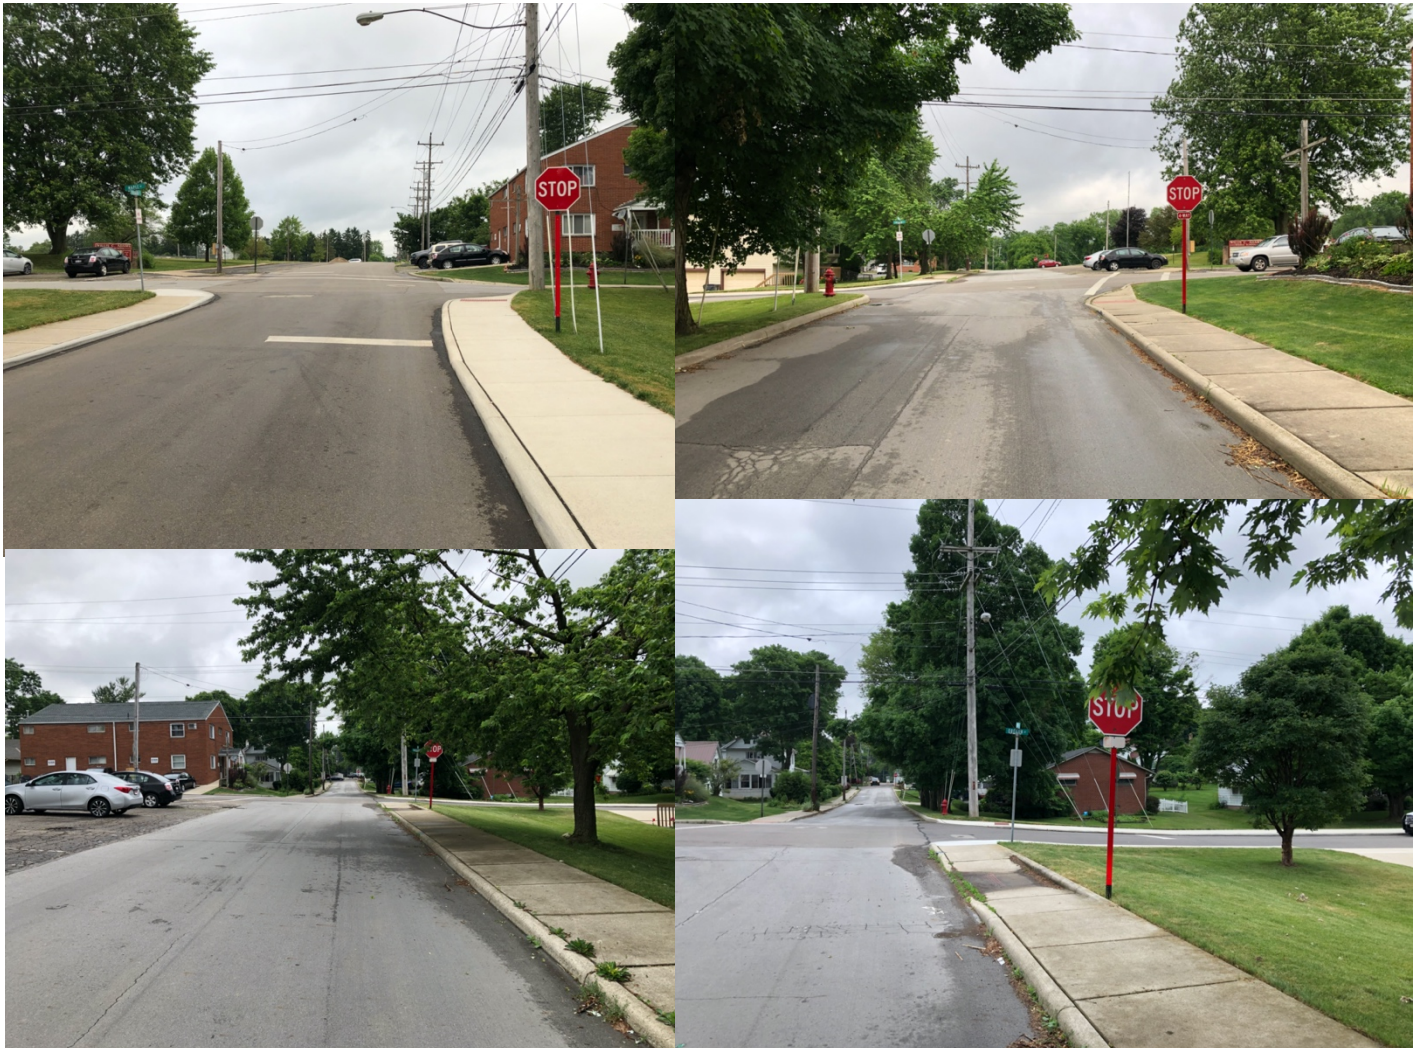
### **South Oregon Street at West Maple Street**

**Onsite observations:** Relatively open roadway with overhead wiring. The wiring is likely to be that of communications and power. Some low hanging tree branches are obstructing the view of the traffic control device (stop sign). This intersection does transition from worn asphalt that is likely good friction for rubber tires, to moderately worn asphalt that would likely be close to ideal for surface gription. All traffic control devices (stop signs) within this intersection are in conformance with the Ohio Revised Code. They are placed at an appropriate height, reflective, placed inconspicuously, and perpendicular to the lane of travel. With the aforementioned stated, only some of the signs adequately state; “4-WAY.” As some of the under signage is missing or faded. It was also noted that only the stop signs northbound and southbound had an accompanying stop-bar (white line). While this is not a conformance matrix (if no stop-bar is present, the vehicle will stop in relation to the posted sign), it is my recommendation that they be added for improved visibility.

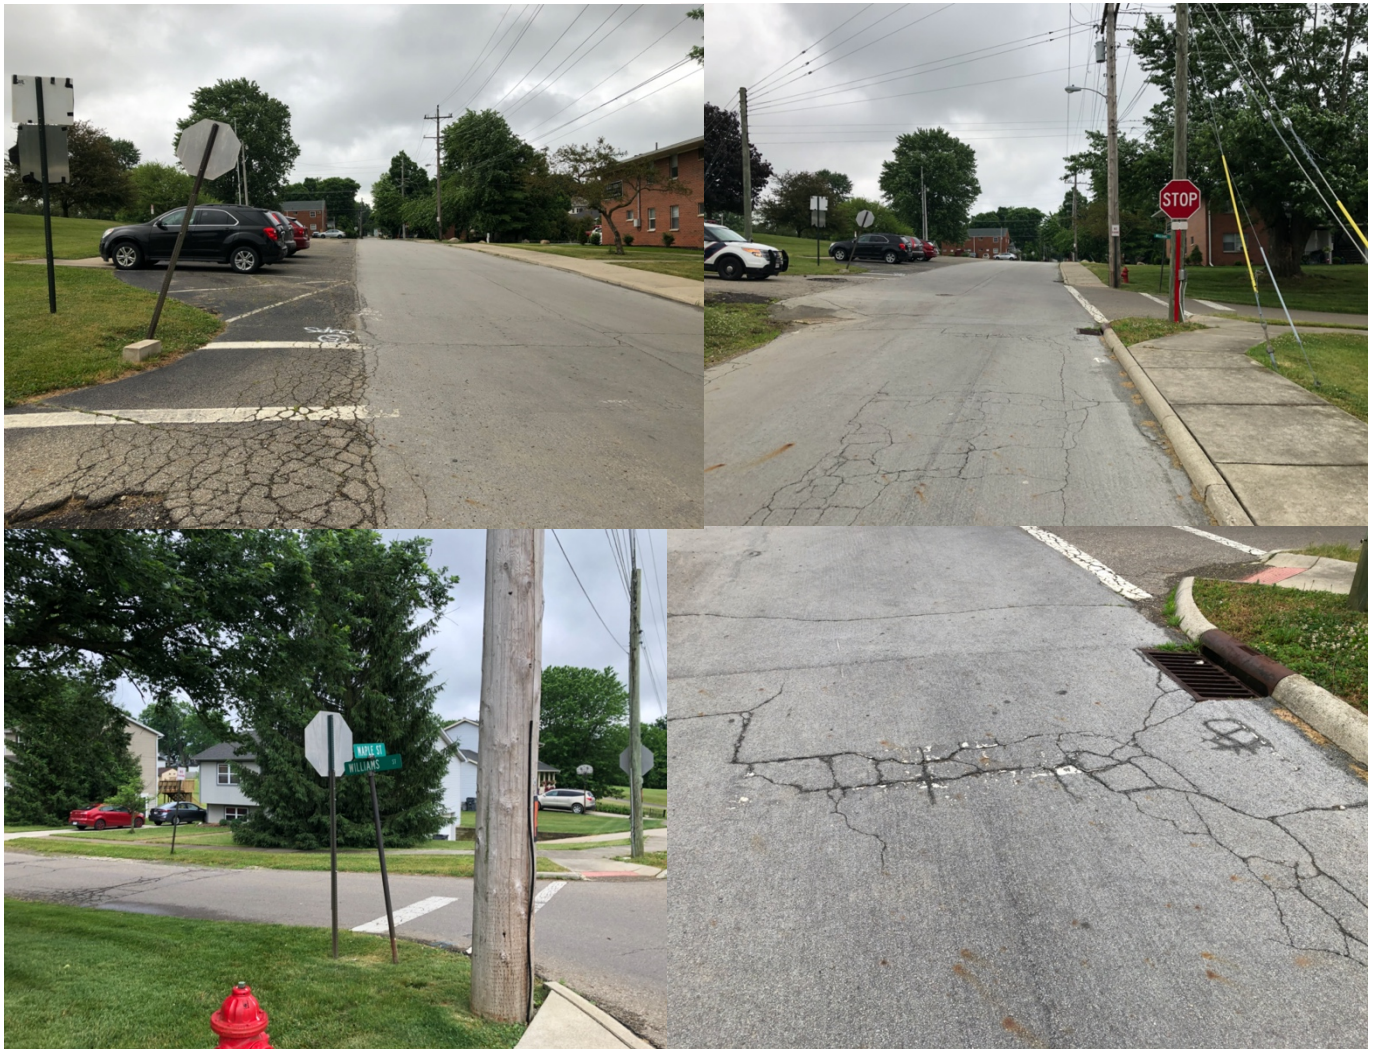
### **West Collage Street at North Williams Street**

**Onsite observations:** Relatively open roadway with overhead wiring. The wiring is likely to be that of communications and power. This intersection is worn asphalt that is likely good friction for rubber tires. Most traffic control devices (stop signs) within this intersection are in conformance with the Ohio Revised Code. They are placed at an appropriate height, reflective, placed inconspicuously, and perpendicular to the lane of travel. With the aforementioned stated, only some of the signs adequately state; “4-WAY.” As the under signage is missing or faded. The sign on the northeast corner is tilting and needs to be reset. It was also noted most of the stop signs had a faded stop-bar (white line). While this is not a conformance matrix (if no stop-bar is present, the vehicle will stop in relation to the posted sign), it is my recommendation that they be added for improved visibility.
