**TRAFFIC SIGN STUDY**

**CHIEF IBRAHIM Y. HAROON**

## Speed Study Mink Street near Hillview Drive

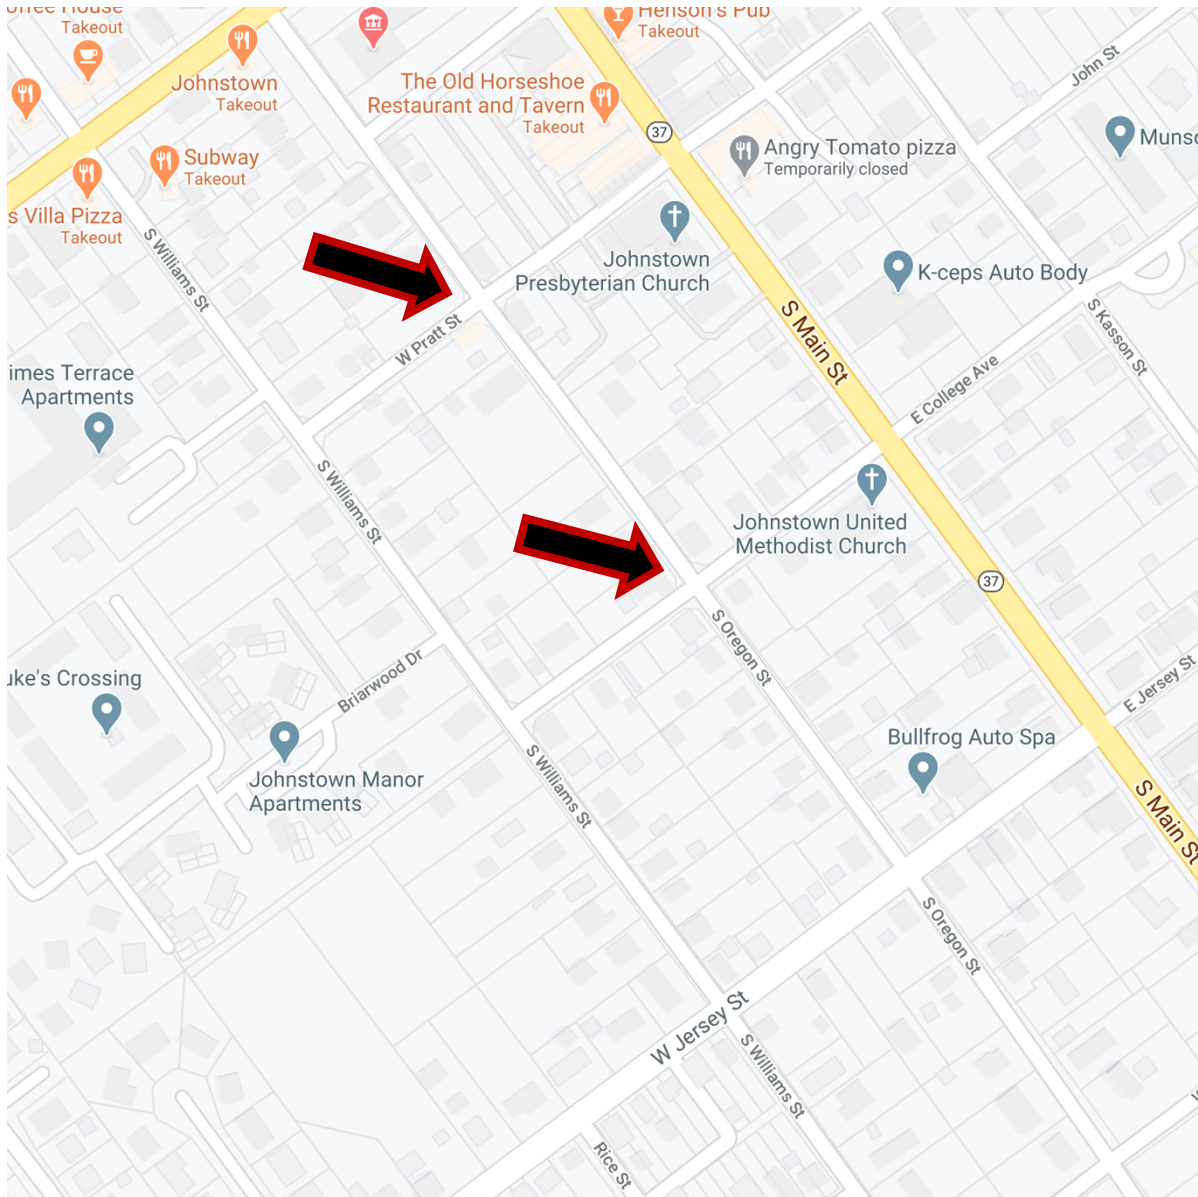
**Location:**  
**South Oregon Street at West Collage Street**  
**South Oregon Street at West Pratt Street**

**Onsite observations:** Relatively open roadway with overhead wiring. The wiring is likely to be that of communications and power. This intersection does transition from relatively poor asphalt that may hinder the friction of rubber tires, to moderately worn asphalt that would likely be close to ideal for surface gription. Most traffic control devices (stop signs) within this intersection are in conformance with the Ohio Revised Code. They are placed at an appropriate height, reflective, placed inconspicuously, and perpendicular to the lane of travel. With the aforementioned stated, none of the signs adequately state; “4-WAY.” As the under signage is faded or missing. The sign on the southwest corner is tilted and likely not to be viewed as perpendicular. It was also noted that none of the stop signs had an accompanying stop-bar (white line). While this is not a conformance matrix (if no stop-bar is present, the vehicle will stop in relation to the posted sign), it is my recommendation that they be added for improved visibility.

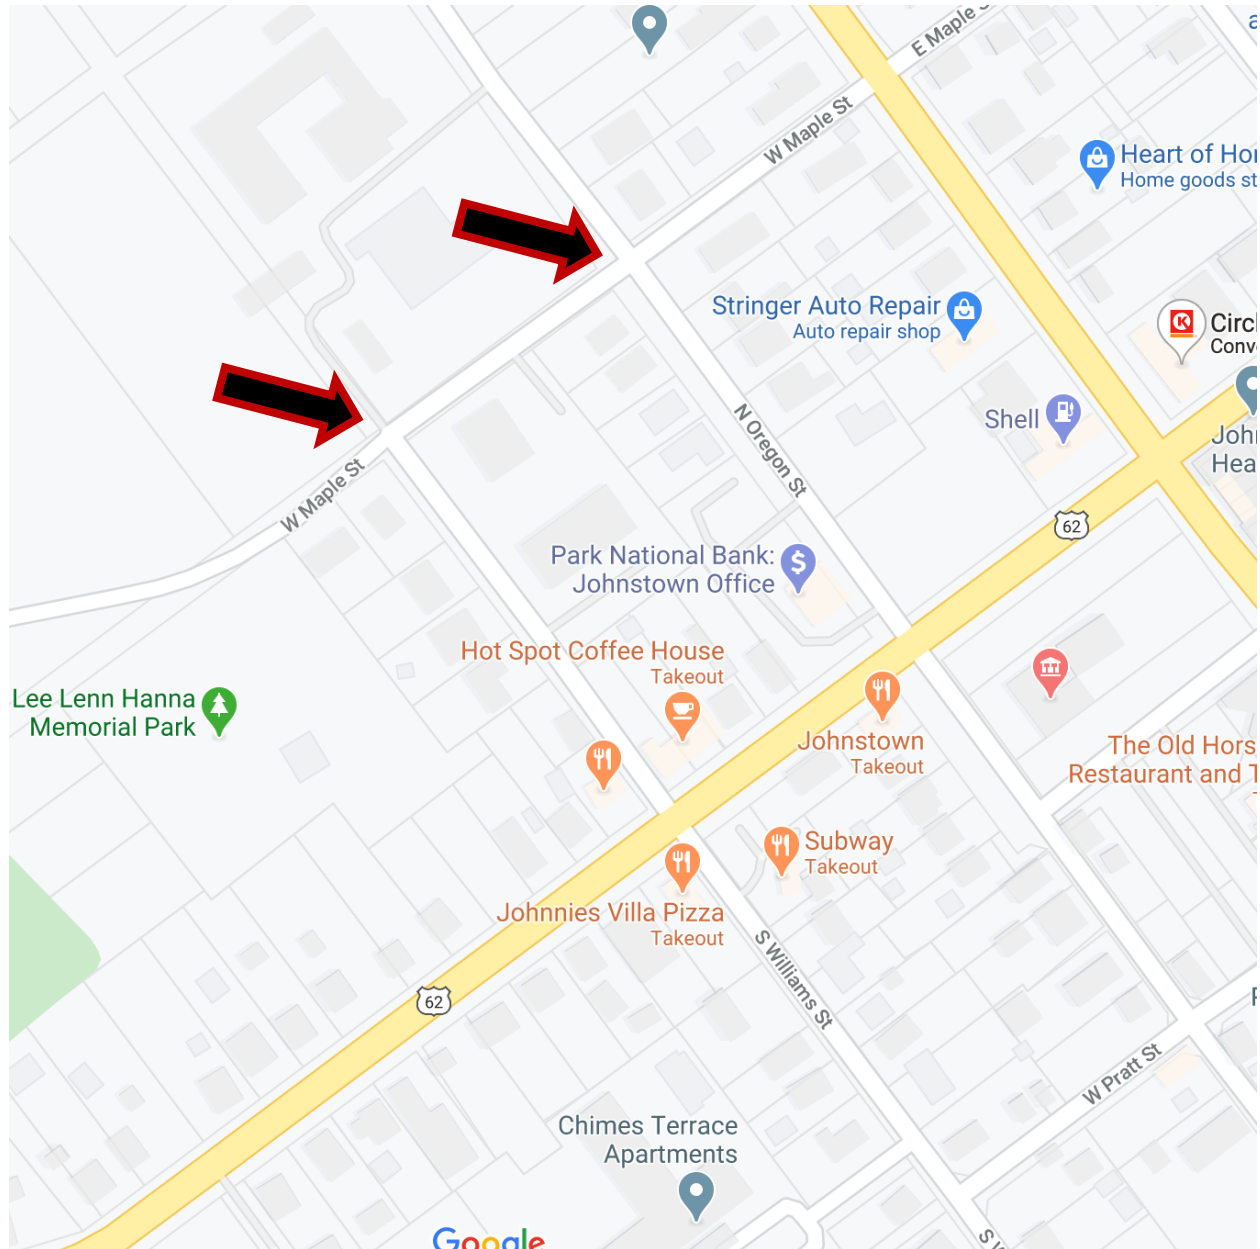
**Location:**  
North Oregon Street at West Maple Street  
West Collage Street at North Williams Street

**Onsite observations:** Relatively open roadway with overhead wiring. The wiring is likely to be that of communications and power. This roadway is relatively poor asphalt that may hinder the friction of rubber tires. All traffic control devices (DO NOT ENTER & ONE WAY) are in conformance with the Ohio Revised Code. They are placed at an appropriate height, reflective, placed inconspicuously, and perpendicular to the lane of travel. It was noted that the stop sign at the intersection of West Pratt Street and South Main Street was slightly obscured by a small tree. It was also noted that the stop signs had an accompanying stop-bar (white line). I had no outward recommendations for this area.

**Onsite observations:** Relatively open roadway with overhead wiring. The wiring is likely to be that of communications and power. Some low hanging tree branches are obstructing the view of the traffic control device (stop sign). This intersection does transition from worn asphalt that is likely good friction for rubber tires, to moderately worn asphalt that would likely be close to ideal for surface gription. All traffic control devices (stop signs) within this intersection are in conformance with the Ohio Revised Code. They are placed at an appropriate height, reflective, placed inconspicuously, and perpendicular to the lane of travel. With the aforementioned stated, only some of the signs adequately state; “4-WAY.” As some of the under signage is missing or faded. It was also noted that only the stop signs northbound and southbound had an accompanying stop-bar (white line). While this is not a conformance matrix (if no stop-bar is present, the vehicle will stop in relation to the posted sign), it is my recommendation that they be added for improved visibility.
